*CCTV CONDUIT CONDITION  
INSPECTIONS –  
THE IMPORTANCE OF TRAINING  
OPERATORS AND THE CLIENT*

Steve Weatherstone  
Streamline Learning

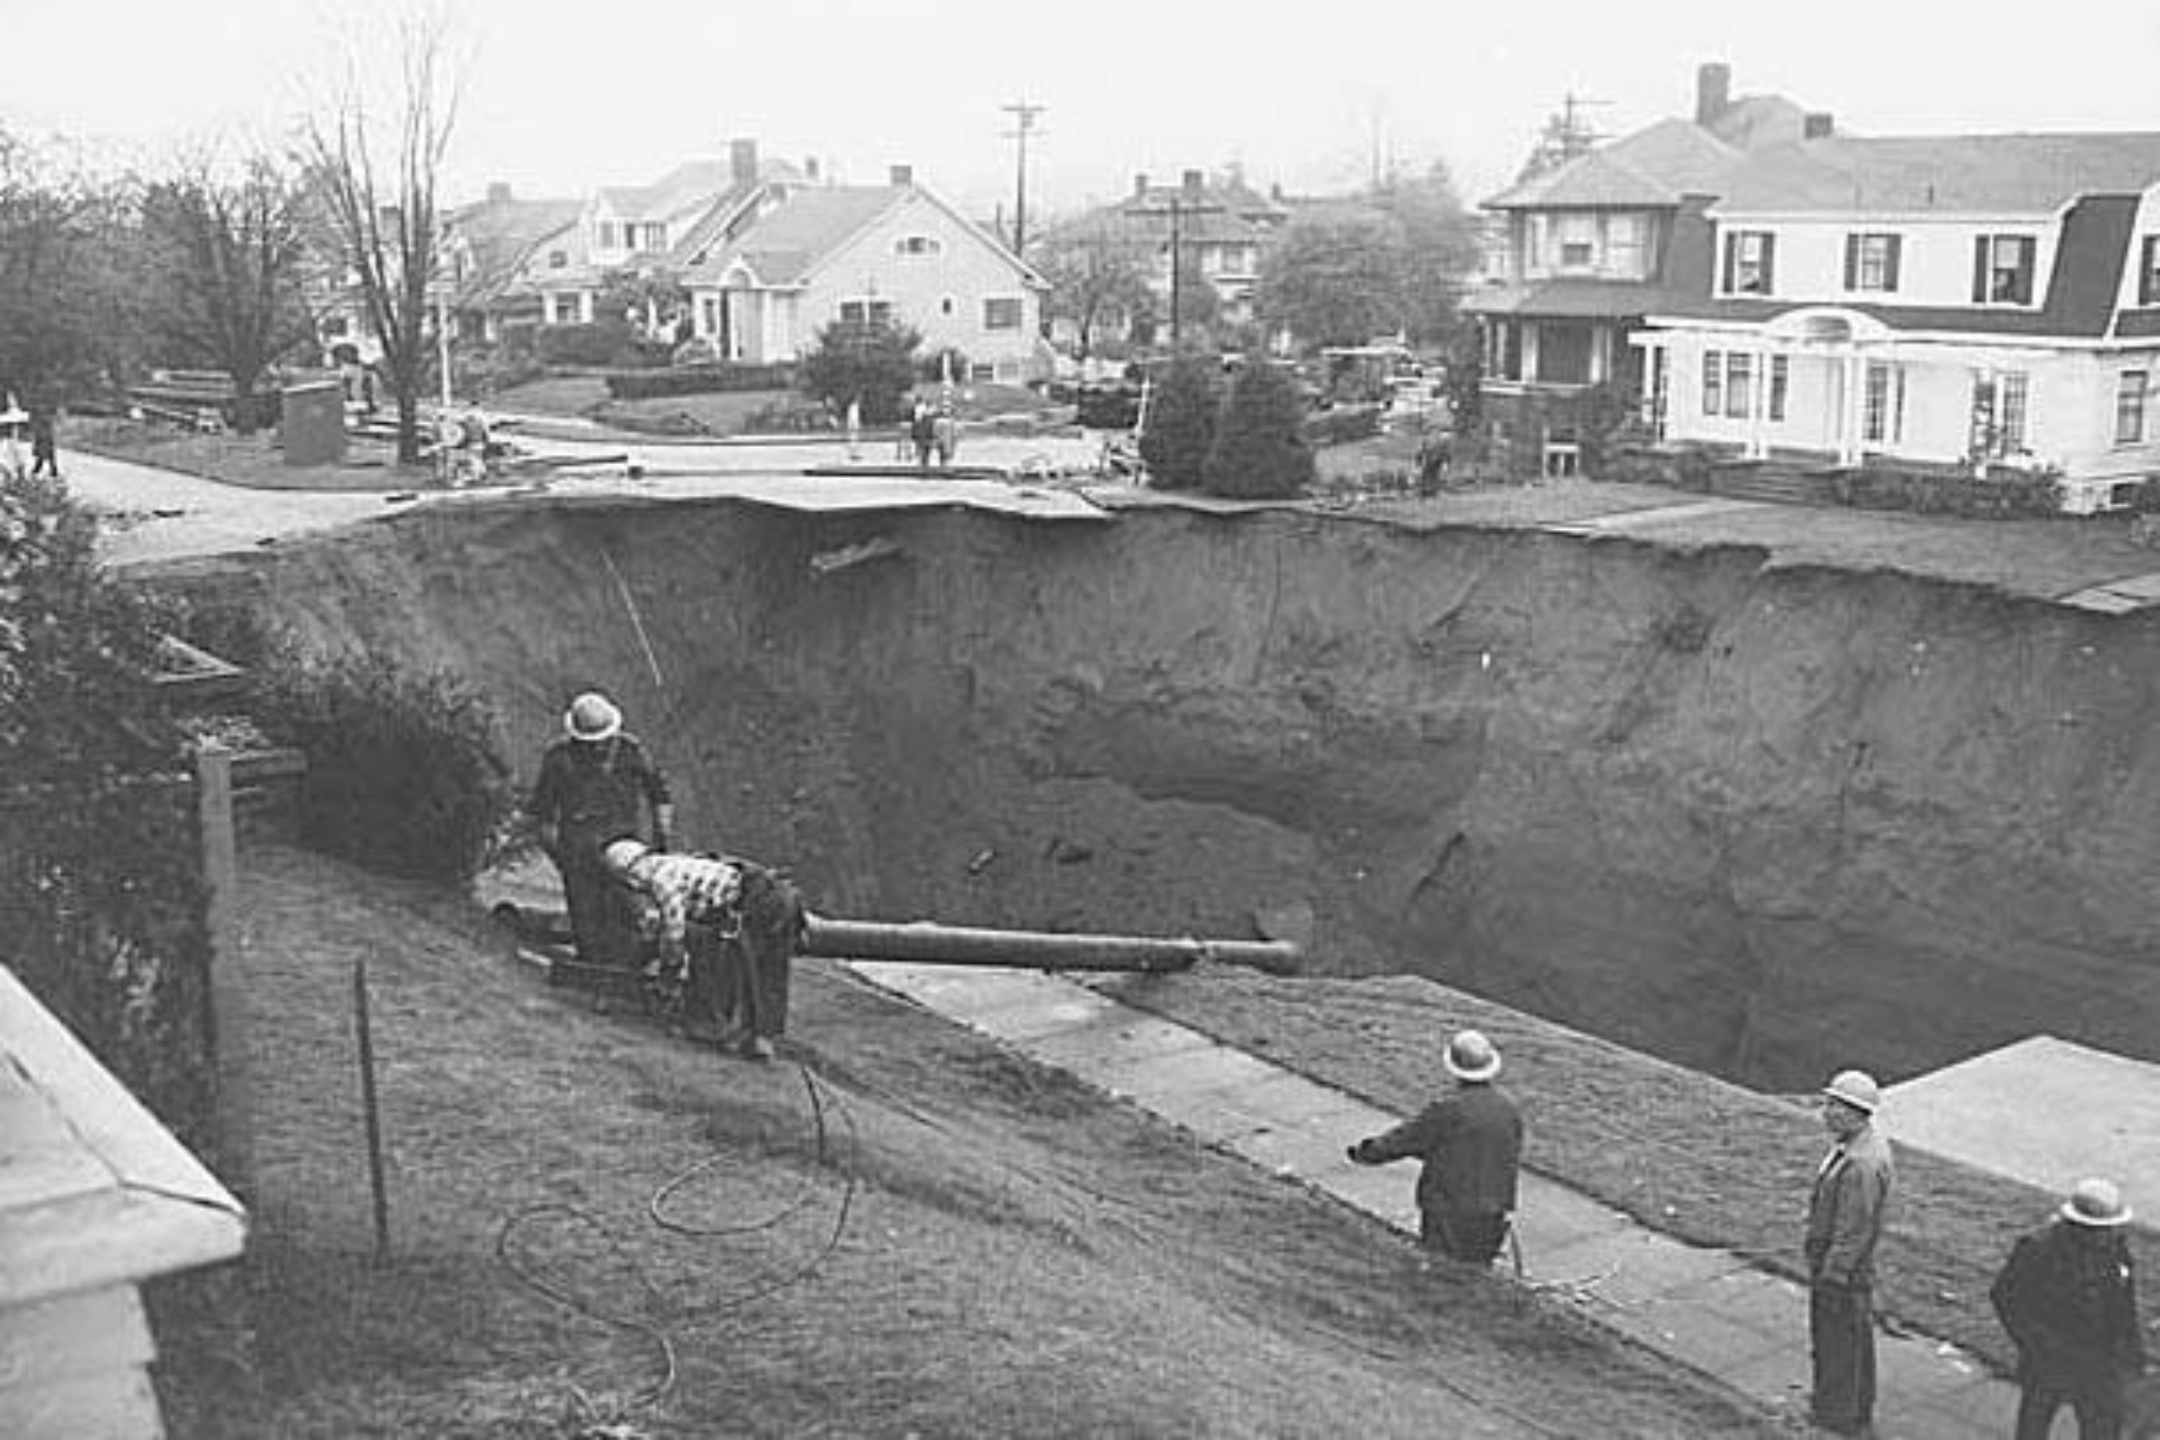
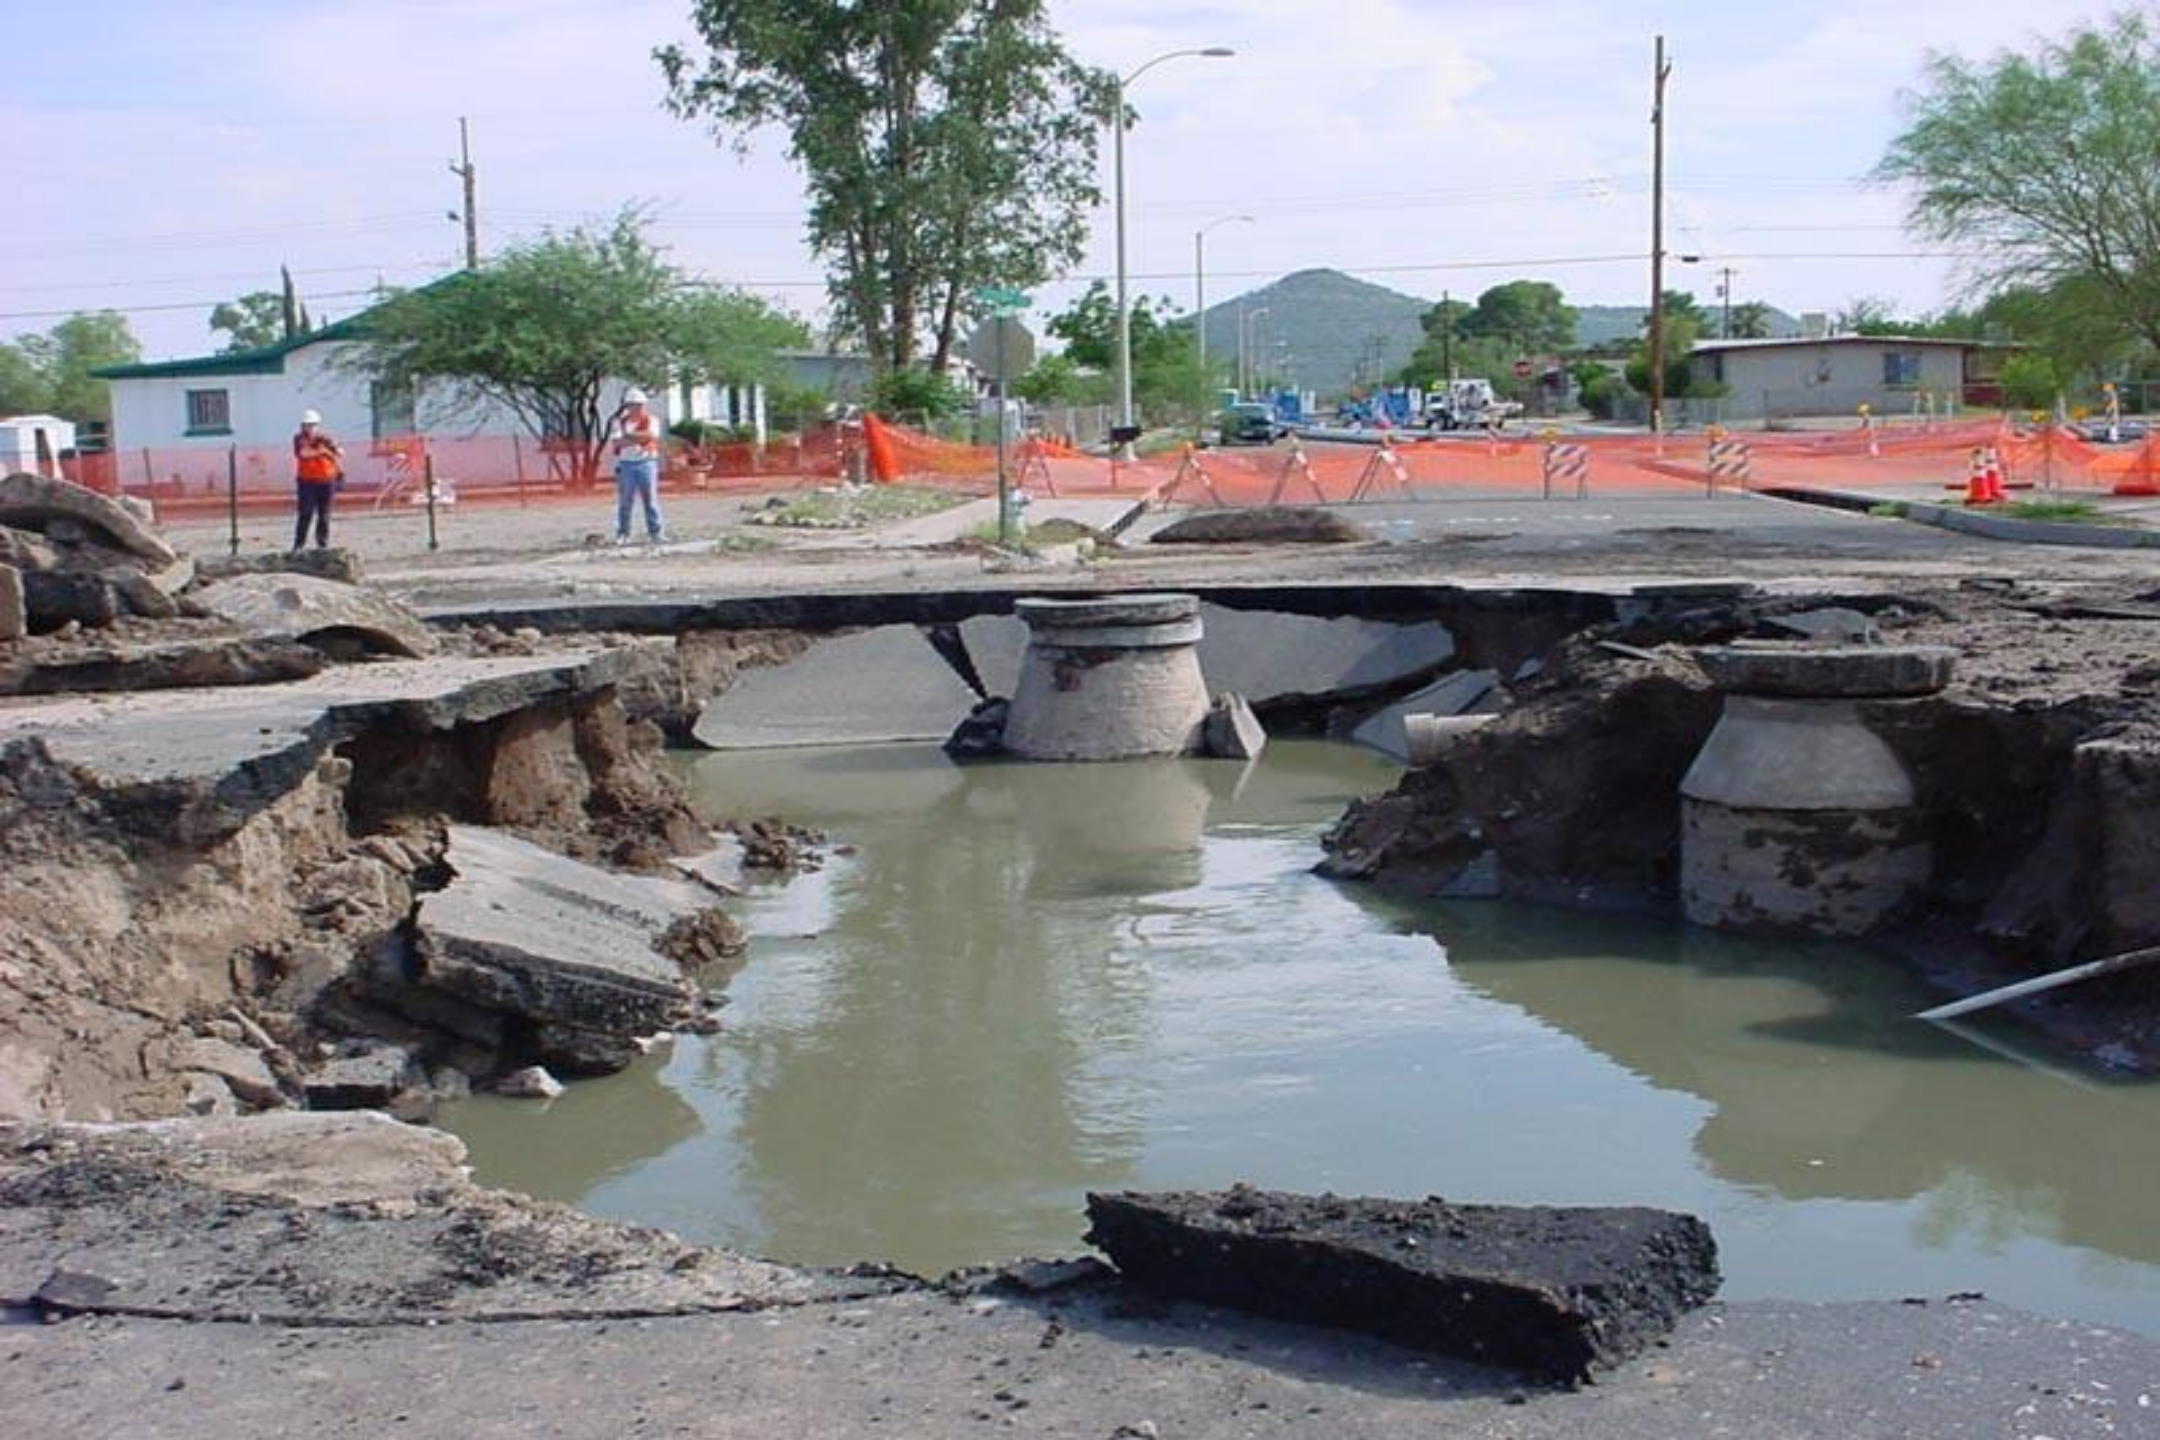
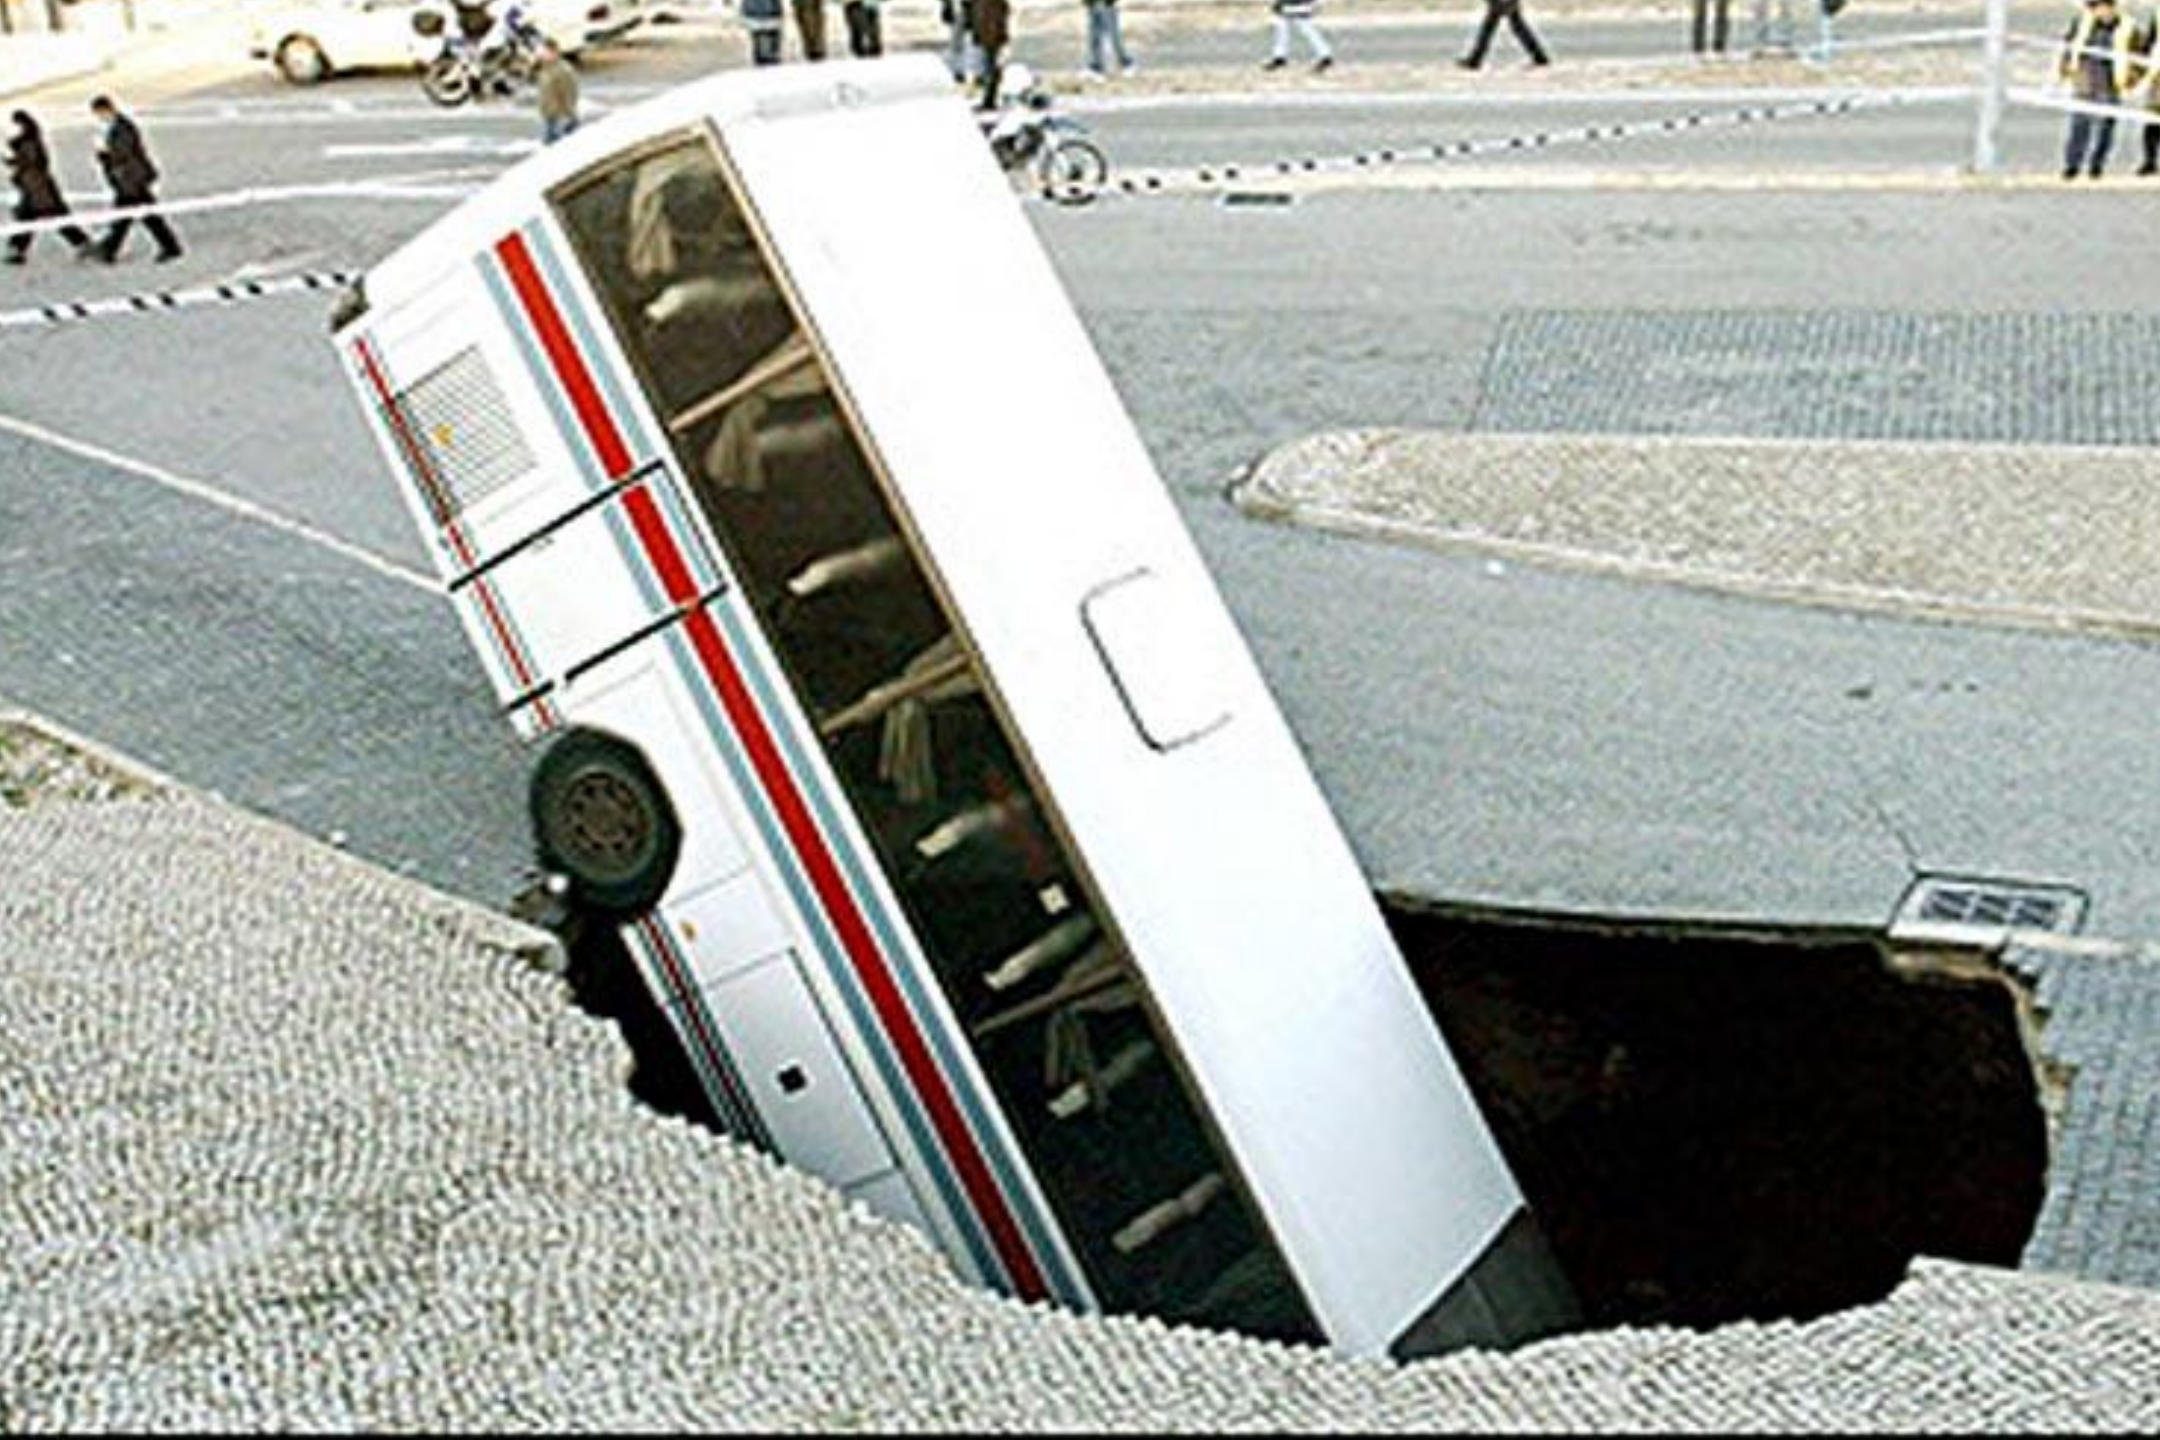
# An all too common event!

- ▶ That massive hole appeared in Gosford street last week after torrential rain
- ▶ The reason – a DN1200 concrete sewer had been weakened, probably due to the corroding effects of  $H_2S$ , and the surcharged condition of the sewer during heavy rain caused the top of the pipe to disintegrate
- ▶ Then sewage saturated the surrounding ground
- ▶ As the surcharged condition subsided the ‘liquefied’ ground flowed into the pipe through the hole

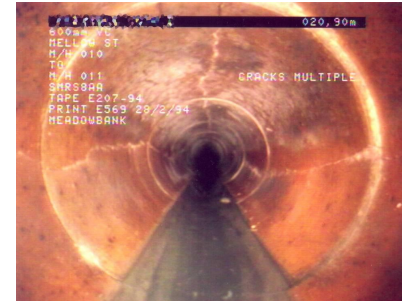
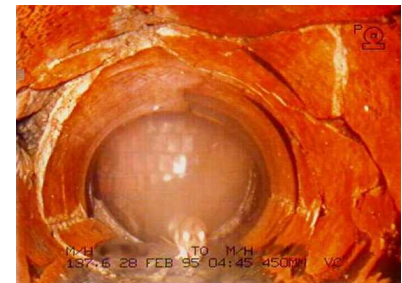
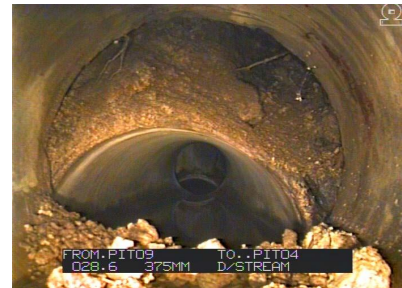
# Examples of scoring

- ▶ CASE 1: CLW @ 12 o'clock – 2
  - For the four reported longitudinal cracks these are added to give a total score of 8 in one metre
  - The cracks are also continuous so this score will be repeated every metre until those defects are no longer present
- ▶ CASE 2: BM – 60
  - Broken missing is the worst category for breaking
- ▶ CASES 3 & 4: X – 165
  - Collapse is catastrophic in terms of structure and service and the score reflects this situation

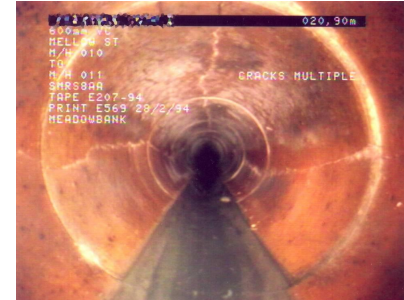
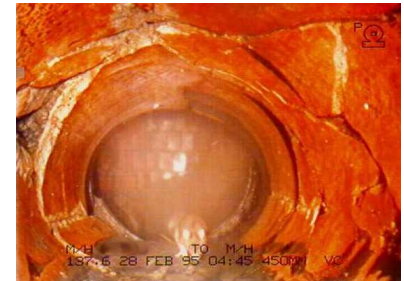
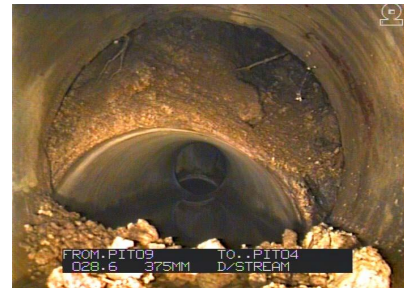
# Structural grading example

- If the cracking continued for the full length the mean score would be 8 per metre and fall in the Grade 5 range for the conduit
- If there were only three longitudinal cracks the score per metre would be 6 and the conduit would be Grade 4

- The peak score of 60 puts the conduit in the Grade 5 range

- These both have a peak score of 165 which is clearly in the Grade 5 range
